# REPORT

**Skoda**

| Model | <b>Tour</b> |
| VIN | <b>TMBDX21U478857234</b> |

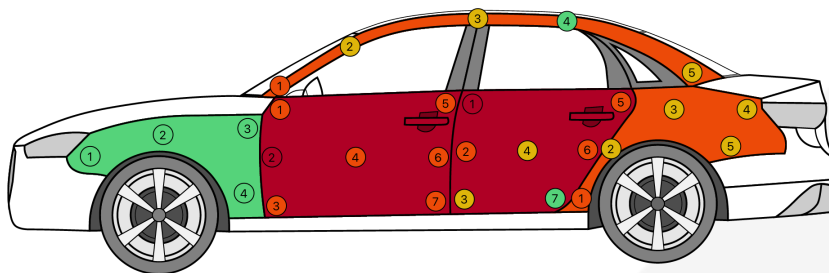
| LEFT SIDE | | | | | | | | | | | |

| LEFT SIDE | | | | | | | | | | | |
|---|---|---|---|---|---|---|---|---|---|---|---|
| left front fender/<br>bumper | Fe | 127 | 156 | 144 | 141 | 154 | 156 | 127 | - | - | - |
| left front door | Fe+Zn | 398 | 811 | 496 | 453 | 811 | 492 | 450 | 421 | 448 | 398 |
| left rear door | Fe | 125 | 879 | 374 | 879 | 374 | 281 | 296 | 313 | 350 | 125 |
| left pillar | Fe+Zn | 154 | 357 | 217 | 357 | 217 | 190 | 154 | 166 | - | - |
| left rear fender/<br>bumper | Fe+Zn | 167 | 320 | 237 | 320 | 294 | 199 | 207 | 167 | - | - |

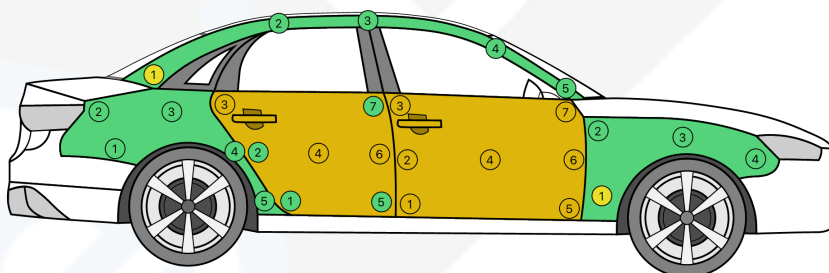
| RIGHT SIDE | | | | | | | | | | | |

| RIGHT SIDE | | | | | | | | | | | |
|---|---|---|---|---|---|---|---|---|---|---|---|
| right front fender/<br>bumper | Fe | 51 | 97 | 73 | 51 | 73 | 71 | 97 | - | - | - |
| right front door | Fe | 238 | 267 | 249 | 238 | 267 | 242 | 241 | 242 | 250 | 265 |
| right rear door | Fe+Zn | 103 | 191 | 157 | 147 | 151 | 177 | 184 | 143 | 191 | 103 |
| right pillar | Fe+Zn | 68 | 124 | 101 | 68 | 106 | 103 | 102 | 124 | - | - |
| right rear fender/<br>bumper | Fe+Zn | 116 | 128 | 122 | 116 | 118 | 128 | 124 | 124 | - | - |

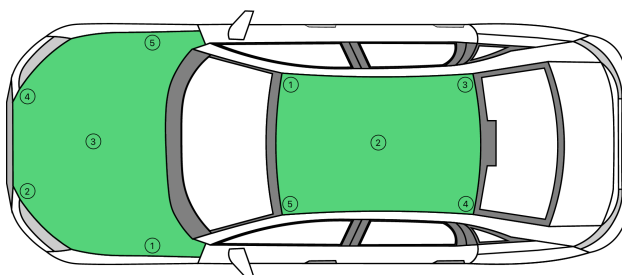
| TOP | | | | | | | | | | | |

| TOP | | | | | | | | | | | |
|---|---|---|---|---|---|---|---|---|---|---|---|
| hood/bonnet | Fe | 76 | 150 | 115 | 119 | 126 | 104 | 150 | 76 | - | - |
| roof | Fe+Zn | 90 | 129 | 105 | 90 | 103 | 129 | 103 | 98 | - | - |

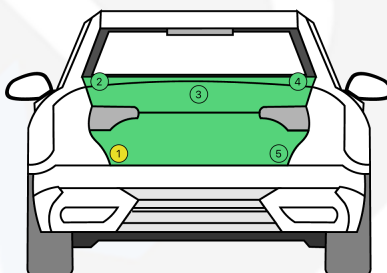
| BACK | | | | | | | | | | | |

| BACK | | | | | | | | | | | |
|---|---|---|---|---|---|---|---|---|---|---|---|
| trunk/boot | Fe+Zn | 70 | 121 | 92 | 70 | 92 | 121 | 98 | 81 | - | - |

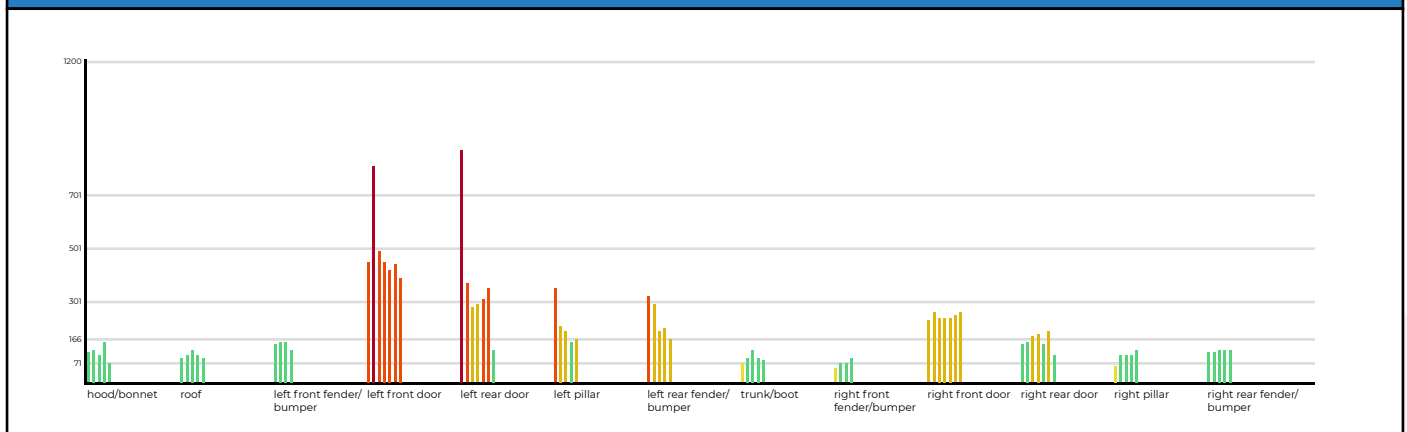
## EXTERNAL MEASUREMENTS

| EXTERNAL MEASUREMENTS | | | | | | | | | | | | | | |
|---|---|---|---|---|---|---|---|---|---|---|---|---|---|---|
| left front fender/<br>bumper | 1.<br>141 | 2.<br>154 | 3.<br>156 | 4.<br>127 | - | - | - | - | - | - | - | - | - | - |
| right front fender/<br>bumper | 4.<br>97 | 3.<br>71 | 2.<br>73 | 1.<br>51 | - | - | - | - | - | - | - | - | - | - |
| <b>DIFFERENCE</b> | <b>44</b> | <b>83</b> | <b>83</b> | <b>76</b> | | | | | | | | | | |
| left front door | 1.<br>453 | 2.<br>811 | 3.<br>492 | 4.<br>450 | 5.<br>421 | 6.<br>448 | 7.<br>398 | - | - | - | - | - | - | - |
| right front door | 7.<br>265 | 6.<br>250 | 5.<br>242 | 4.<br>241 | 3.<br>242 | 2.<br>267 | 1.<br>238 | - | - | - | - | - | - | - |
| <b>DIFFERENCE</b> | <b>188</b> | <b>561</b> | <b>250</b> | <b>209</b> | <b>179</b> | <b>181</b> | <b>160</b> | | | | | | | |
| left rear door | 1.<br>879 | 2.<br>374 | 3.<br>281 | 4.<br>296 | 5.<br>313 | 6.<br>350 | 7.<br>125 | - | - | - | - | - | - | - |
| right rear door | 7.<br>103 | 6.<br>191 | 5.<br>143 | 4.<br>184 | 3.<br>177 | 2.<br>151 | 1.<br>147 | - | - | - | - | - | - | - |
| <b>DIFFERENCE</b> | <b>776</b> | <b>183</b> | <b>138</b> | <b>112</b> | <b>136</b> | <b>199</b> | <b>22</b> | | | | | | | |
| left pillar | 1.<br>357 | 2.<br>217 | 3.<br>190 | 4.<br>154 | 5.<br>166 | - | - | - | - | - | - | - | - | - |
| right pillar | 5.<br>124 | 4.<br>102 | 3.<br>103 | 2.<br>106 | 1.<br>68 | - | - | - | - | - | - | - | - | - |
| <b>DIFFERENCE</b> | <b>233</b> | <b>115</b> | <b>87</b> | <b>48</b> | <b>98</b> | | | | | | | | | |
| left rear fender/<br>bumper | 1.<br>320 | 2.<br>294 | 3.<br>199 | 4.<br>207 | 5.<br>167 | - | - | - | - | - | - | - | - | - |
| right rear fender/<br>bumper | 5.<br>124 | 4.<br>124 | 3.<br>128 | 2.<br>118 | 1.<br>116 | - | - | - | - | - | - | - | - | - |
| <b>DIFFERENCE</b> | <b>196</b> | <b>170</b> | <b>71</b> | <b>89</b> | <b>51</b> | | | | | | | | | |
