GENERAL INFORMATION

Report Name	Ford Fusion
Serial number	10373 PROFESSIONAL
Unit of measure	µm

Type	SEDAN
Make	Ford
Model	Fusion
Engine capacity [ccm]	2488
Power [kW]	128
VIN	3FA6P0G74GR273418
Fuel Type	Gas+LPG
Year of production	2015

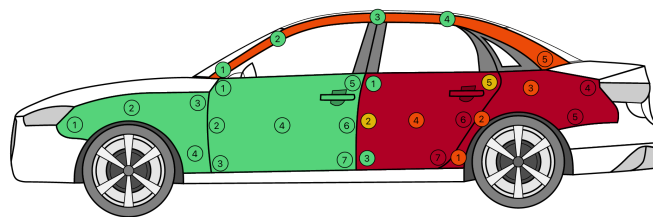
PAS: general interpretation, body

LEFT FRONT FENDER/ BUMPER

Coating	Fe
Minimum	105
Maximum	136
Medium	126
1.	105
2.	136
3.	133
4.	129

LEFT FRONT DOOR

Coating	Fe
Minimum	103
Maximum	146
Medium	127
1.	104
2.	135
3.	103
4.	146
5.	120
6.	141
7.	142

LEFT REAR DOOR

Coating	Fe
Minimum	142
Maximum	1613
Medium	450
1.	142
2.	174
3.	147
4.	324
5.	192
6.	561
7.	1613

LEFT PILLAR

Coating	Fe
Minimum	129
Maximum	374
Medium	187
1.	149
2.	132
3.	129
4.	152
5.	374

LEFT REAR FENDER/ BUMPER

Coating	Fe
Minimum	306
Maximum	979
Medium	521
1.	324
2.	476
3.	306
4.	518
5.	979

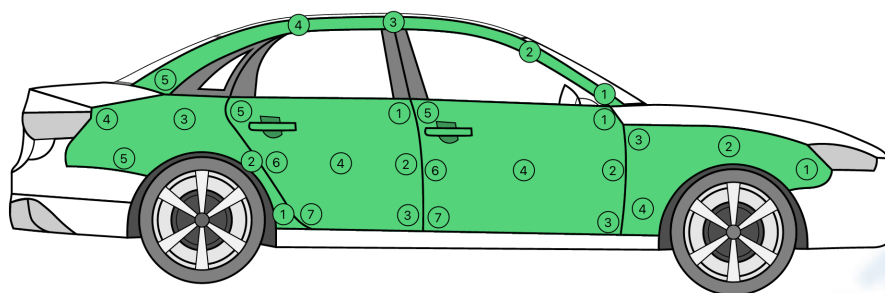
**RIGHT REAR FENDER/
BUMPER**

Coating	Fe
Minimum	119
Maximum	157
Medium	131
1.	157
2.	130
3.	126
4.	119
5.	123

RIGHT PILLAR

Coating	Fe
Minimum	115
Maximum	140
Medium	121
1.	117
2.	140
3.	118
4.	115
5.	117

RIGHT REAR DOOR

Coating	Fe
Minimum	107
Maximum	139
Medium	117
1.	115
2.	111
3.	107
4.	122
5.	139
6.	113
7.	110

RIGHT FRONT DOOR

Coating	Fe
Minimum	95
Maximum	133
Medium	120
1.	114
2.	128
3.	95
4.	129
5.	133
6.	117
7.	126

**RIGHT FRONT
FENDER/BUMPER**

Coating	Fe
Minimum	121
Maximum	140
Medium	128
1.	125
2.	140
3.	125
4.	121

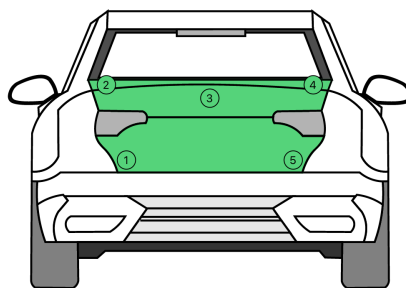
TRUNK/BOOT

Coating	Fe
Minimum	117
Maximum	149
Medium	134
1.	140
2.	135
3.	127
4.	149
5.	117

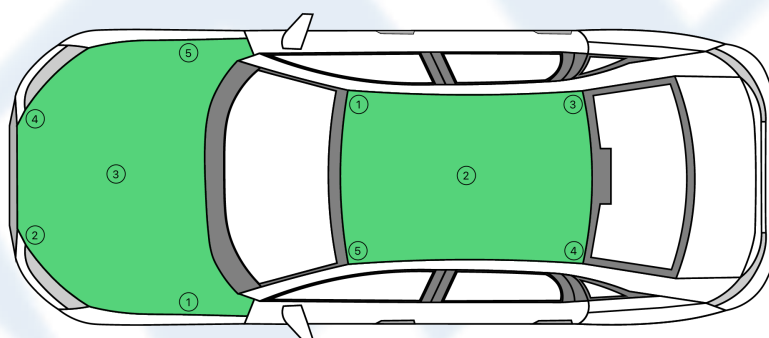
HOOD/BONNET

Coating	Al
Minimum	89
Maximum	121
Medium	107
1.	89
2.	114
3.	121
4.	114
5.	98

ROOF

Coating	Fe
Minimum	102
Maximum	138
Medium	124
1.	102
2.	124
3.	138
4.	125
5.	131
